JAMES DAVIDSON ARCHITECT

TYPE OF DAMAGE SEEN DURING EAA ASSESSMENTS

**BUILDING ASSESSMENT REPORT**

# Part 2 - Flood resilient strategies

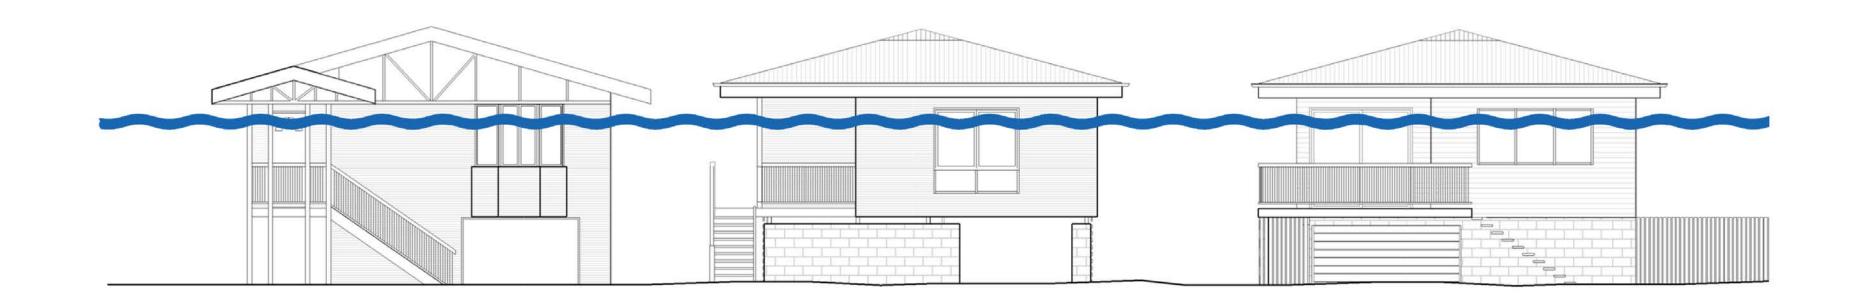
Graceville Ave – 2011 inundation levels including neighbouring houses
