Assessment of options to improve amenity and performance of the Roselea Boulevard Compensation Basin, City of Stirling

Carolyn Oldham and Carlos Ocampo, The University of Western Australia

Cooperative Research Centre for Water Sensitive Cities Regional Project 6.4

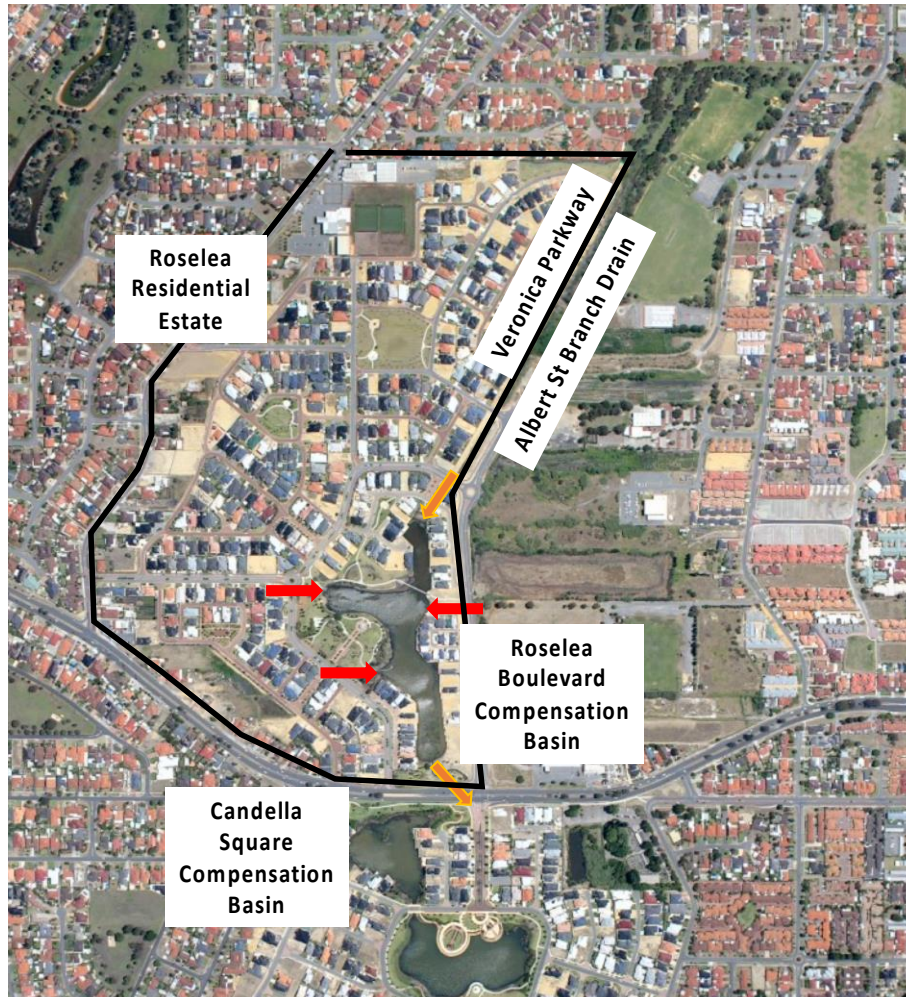
Figure 2. Albert St Branch Drain inflows and outflows (orange), and road runoff inflows (red) into the Roselea Blvd Compensation Basin (Nearmap, December 2009).

Static water level = RL10.2
Base of basin = RL 7.5
Storage volume S_{10} = 44,800 m³
Storage volume S_{100} = 68,700 m³
Normal water surface area – 2.34 Ha
Storage volume at RL10.2 – 30.690 m³

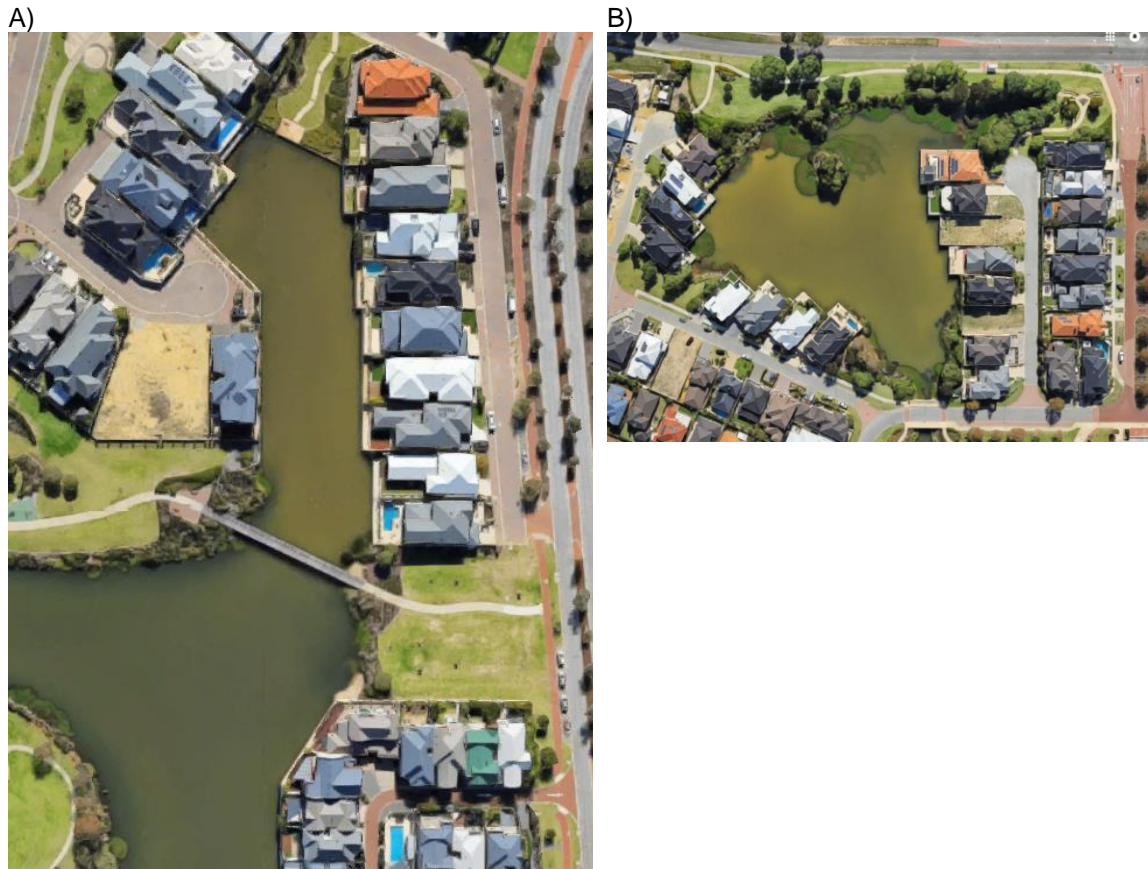
Figure 3. Water quality issues are visible most years May-June in a) the northern-most section of Roselea Compensating Basin, and b) the Candella Square Compensation Basin (CSCB) (Nearmap, June 2007).

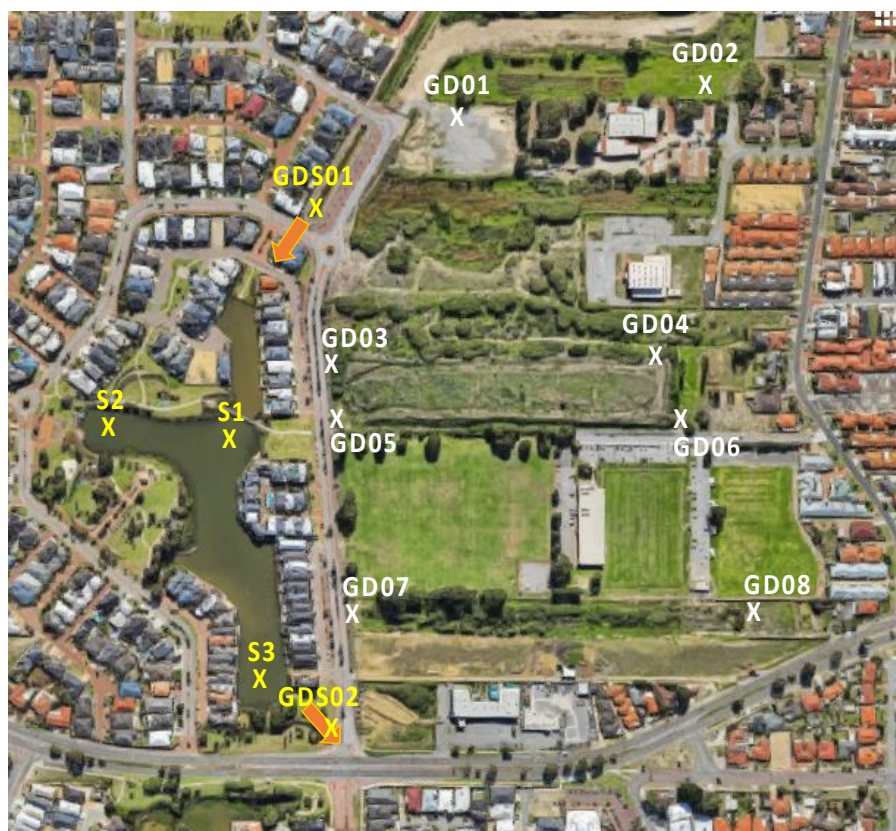
Figure 4. Historical and current monitoring sites around RSCB. Surface and bottom water samples were collected from S1, S2 and S3 and analysed for a range of chemicals (Appendix 1A) in 2008. Surface water sites GDS01 and GDS02, and groundwater sites GD01, 02, 03, 04, 05, 06, 07, and 08, were monitored for a range of physico-chemical properties in 2017-2018; water samples were also collected from some of these sites and analysed for nutrients.

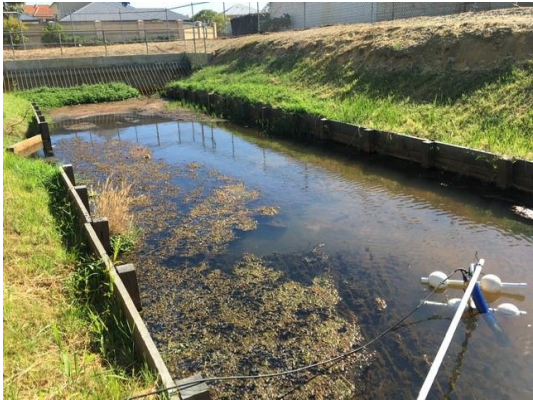
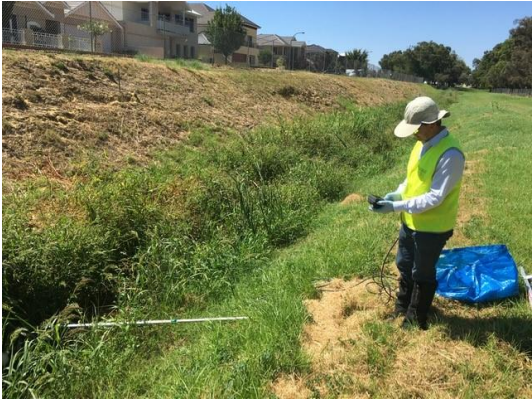
Figure 5. Water quality measurements in ASBD.

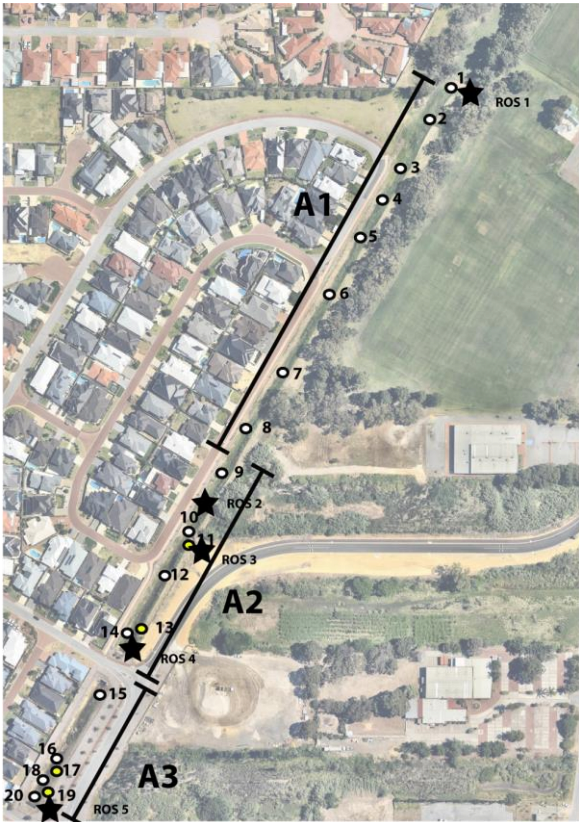
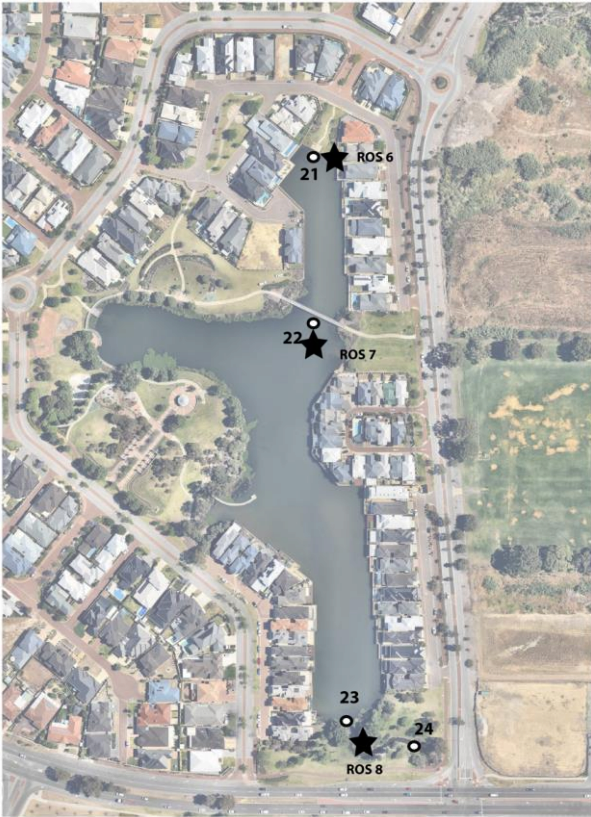
Figure 6. Location of surface water quality measurements along ASBD (left) and RBCB (right). Dots and numbers indicate water quality measurement location. Star symbols followed by identification name (ROS 1) indicate water sampling for nutrient analysis undertaken in February 22 2019 (Source: Nearmap).

Water sample collection for nutrient analysis (nitrogen and phosphorus) was conducted in February 22 2019 after the occurrence of an algal bloom in the northern section of RCB (point 21 in Figure 6). The incident was reported to Water Corporation on February 15 by residents (N. Scott, pers. comm.). Warm weather conditions prevailed during the previous week (temperatures above 35 °C) and contractors removed lake macrophytes and floating residues on February 20 and 21, i.e. prior to the sampling date. Water quality measurements were also taken on February 22. Base flow conditions were measured in the ASBD, with no precipitation recorded in the area over the previous 7 days, and less than 6 mm over the previous 30 days (<http://www.bom.gov.au>, Perth Metro, Station: 9225).

Eight water samples were collected at representative locations (ROS 1 to ROS 8 in Figure 6). Water samples for dissolved nutrient analysis were filtered in the field (0.45 μm) and stored on ice and transported to the Chemistry Centre of WA (NATA credited). Samples were analysed for total nitrogen (TN), total Kjeldahl nitrogen (TKN), ammonia (NH₃), nitrite+nitrate (NO_x), total phosphorus (TP) and soluble reactive phosphorus (SRP); laboratory results can be found in Appendix 1B.

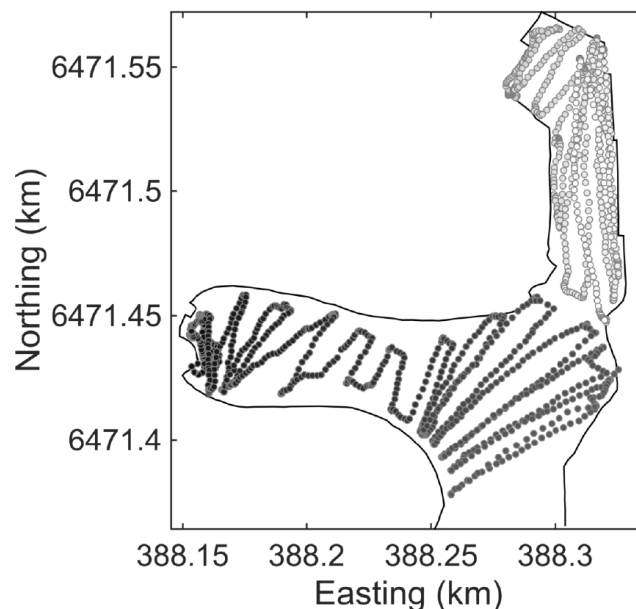
Figure 8. Tracks followed by the hydroboard with temperature and conductivity sensors and GPS. Lake boundaries obtained using Google Earth maps.

A more comprehensive surface water monitoring at the western and northern sections of RBCB was conducted in March 28, 2019 to identify groundwater discharge locations. This activity was restricted to these sections due to difficulties of accessing the private properties along the southern end of the lake. Water temperature and SC sensors with a datalogger (TPS 90LVM) and a GPS logger were fitted on a hydroboard and pulled across the lake to scan the lake surface water. Sensors were deployed at 0.2 m from the water surface and data collected at a 4 second-time interval. Figure 8 shows the different tracks followed by the hydroboard across the lake surface.

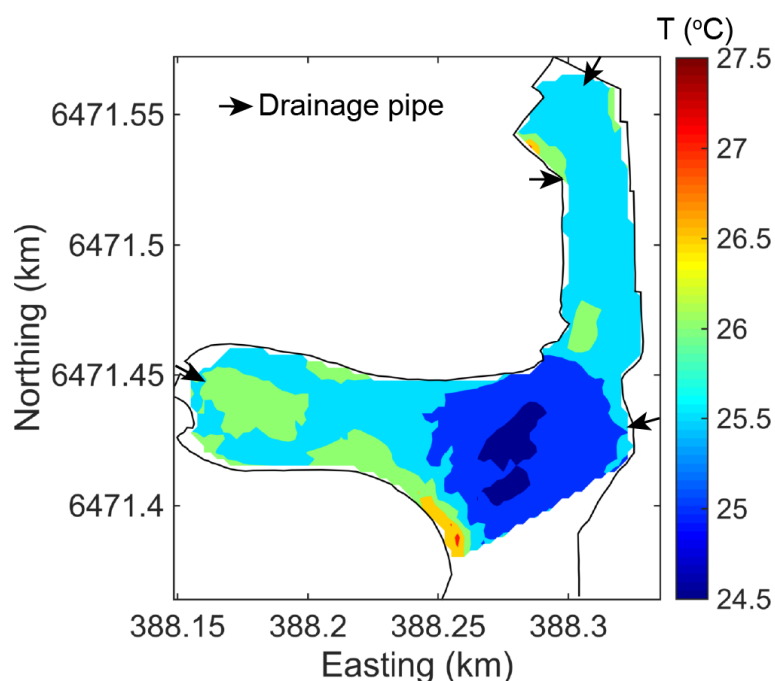
Figure 9. Surface water temperature mapping. Arrows indicate location of drainage pipes entering RCB.

The water temperature mapping (Figure 9) clearly shows the presence of different compartments within the lake. Cooler water was found at the lake centre, coinciding with deeper water (depth > 2.3 m). The northern section presented a more uniform temperature distribution (values of ~25.7 °C) and areas of warmer water (see green spots) in wind protected zones (afternoon south-westerly breeze was recorded during the survey). The western area showed more temperature variability than the northern end, and a warm water spot near the shore. However, temperature mapping was unable to

identify groundwater seepage areas (diffuse) or point sources areas in the proximity to drainage pipes.

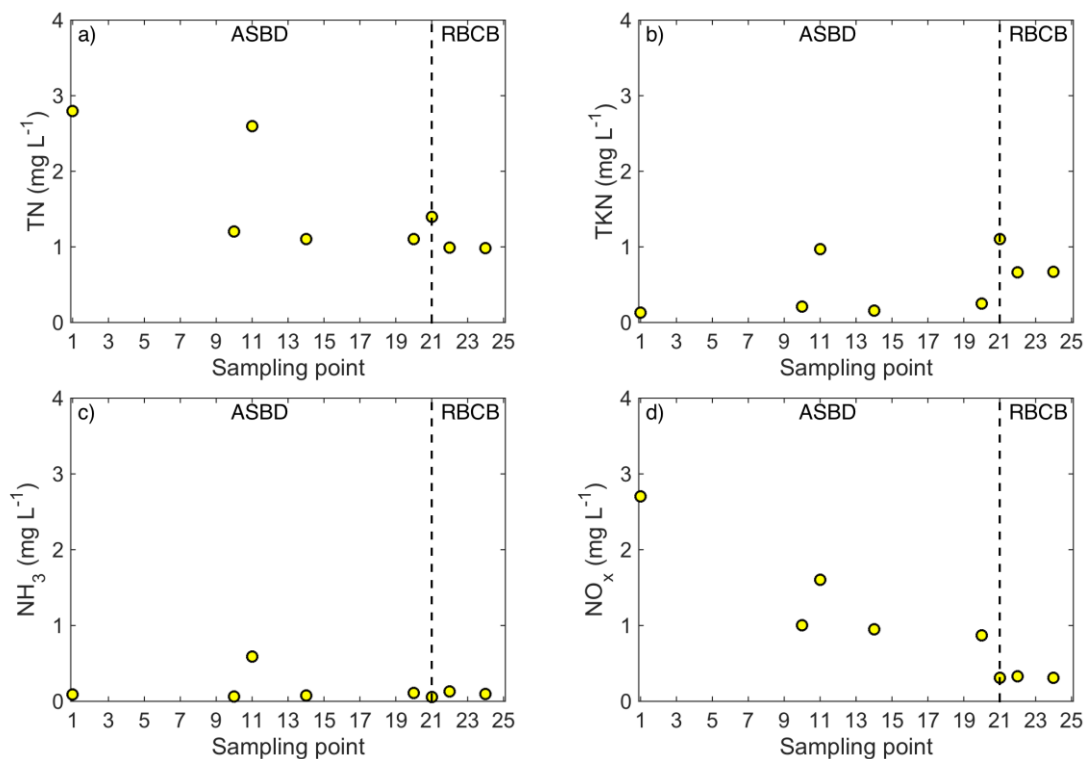
Figure 11. Nitrogen concentration values along the ASBD and RBCB from water samples collected in February 22 2019: a) total nitrogen (TN), b) total Kjeldahl nitrogen (TKN), c) ammonia (NH_3) and d) nitrite+nitrate (NO_x).

Figure 11 shows concentration values for TN and dissolved nitrogen species. Different concentration patterns along the ASBD were identified and will be presented in relation to the nature and amount of the inflow water sources and biogeochemical processes. TN values (Figure 11a) showed a decrease in concentration until sampling point 10 (a reduction of 57 %) but it remained constant along the downstream sections (A2 and A3) as shown by sampling points 14 and 20. The inflow from Grindleford Dr drainage pipe (point 11) showed high TN concentration (2.6 mg/L) and contributed to the observed TN pattern downstream. A similar pattern along ASBD was observed for NO_x (nitrite + nitrate) (Figure 11c), the largest contribution to TN (up to 83 %), with an initial drop of 63 % along the A1 section (sampling point 10). In contrast, the TKN concentration (a measure of organic nitrogen capable of undergoing further transformations) and NH₃ (Figure 11b,c) increased in the downstream direction, particularly around section A2 (point 11) where Grindleford Drive discharge takes place.

At the RBCB, TN showed a decrease of 29 % in concentration values at the northern end section (Figure 11a, points 21 and 22) but displayed a minor change (1 %) when compared to the southern end at the lake's outflow (point 23). It is important to note an increase in TKN (point 21 in Figure 11b) and the dominance of organic nitrogen (1.04 mg/L) in the RBCB waters. On the other hand, TP concentrations at the RBCB showed little variation within the lake with an average value of 0.097 mg/L. As found in the ASBD, SRP represented a small proportion of TP (~ 2.6 %) in the lake water, with concentrations values of 0.0025 mg/L.

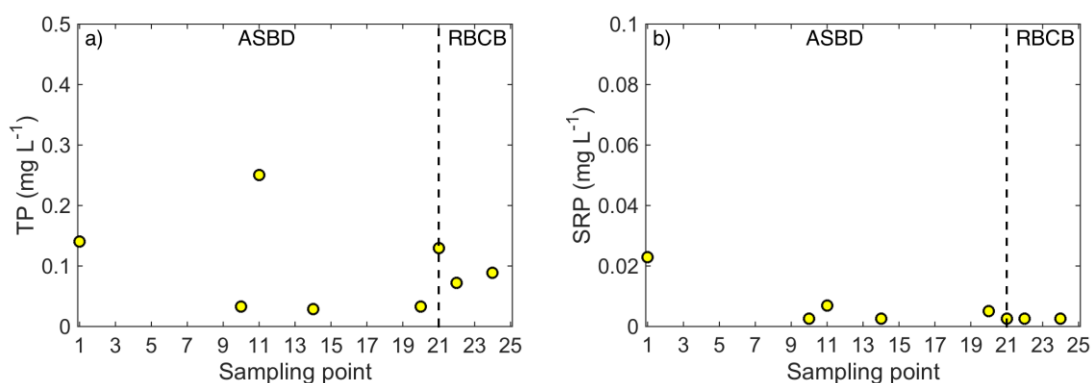
Figure 12. Phosphorus concentration values along the ASBD and RBCB from water samples collected in February 22 2019: a) total phosphorus (TP) and b) soluble reactive phosphorus (SRP).

The TP and SRP concentration values are presented in Figure 12. Along the ASBD, TP showed a similar pattern to those observed for TN and NO_x , with an initial drop in concentration (76 %) followed by steady values before its discharge into RBCB (Figure 12a, point 20). The largest TP concentration (0.25 mg/L) corresponded to water discharged by Grindledford Dr drain. While SRP represented a small portion of TP (less than 10 %) and suggests TP is mainly composed of particulate and organic phosphorus, it followed the same pattern as TP (Figure 12b).

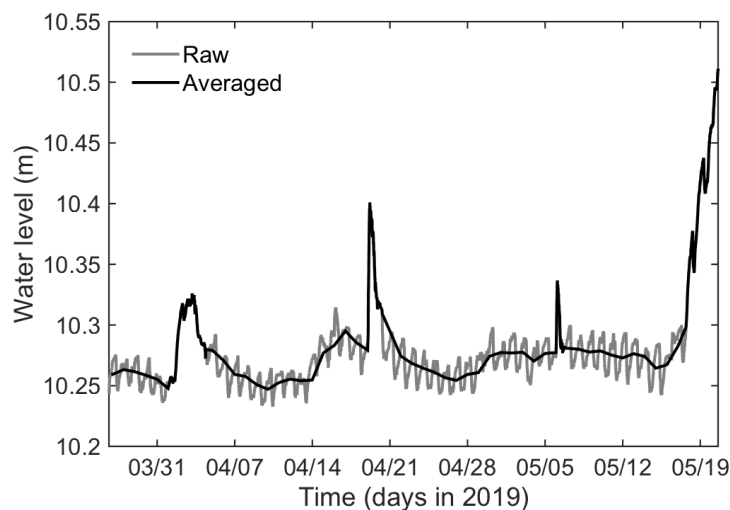
Figure 13. Time series of water level at RBCB: grey line (labelled as raw) represents small diurnal variations in levels and the black line (averaged) represents filtered data plus raw data for individual rainfall events. Water level in metres relative to footbridge level (11.710 m).

Three rainfall events of different magnitude and duration were recorded over the monitoring period, with the largest event on April 19 after an overnight rainfall of 23 mm (<http://www.bom.gov.au>, Perth Metro, Station: 9225). Water levels also showed small, rapid declines (on average 0.03 m) during the morning hours (daily, between 6 am and 10 am) before recovering over the next few hours; this dynamic is consistent with a pump operation cycle, possibly for irrigation of public open space (Figure

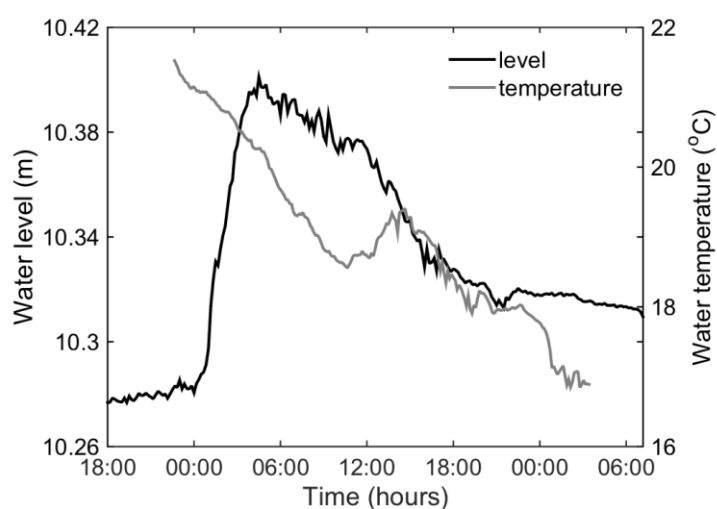
Figure 14. Time series of water level and temperature at RBCB for the April 19 2019 rainfall event. Water level in metres relative to footbridge level (11.710 m).

The water level promptly responded to a 23 mm intense-rainfall event recorded on April 19 2019 (Figure 14). The hydrograph rising limb started at 12:40 am and water level peaked at 10.41 m by 4:30 am. The recession of the hydrograph showed a rapid decrease in water level over the first 12 hours (until 4:50 pm) and continued at a slower rate over the following day. Note that this event was preceded by light rainfall totalling 13 mm, from April 15 to April 17 2019.

As a result of the inflow event on April 19, the water temperature dropped by approximately 4.5 °C (Figure 14) while the air temperature remained relatively constant at around 14 °C over the day (air temperature measured at the lake's shoreline).

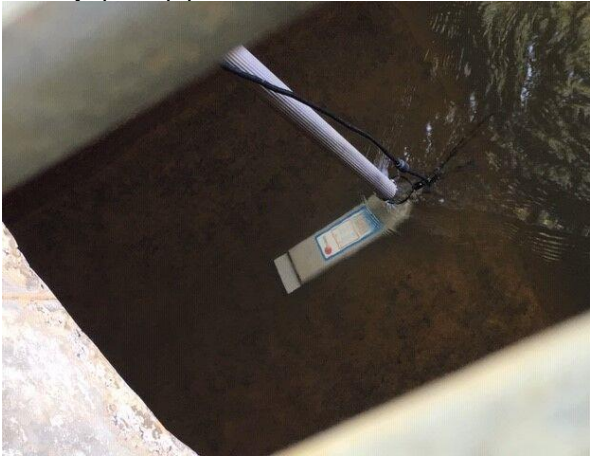
Karrinyup Rd pipe: flow measurement

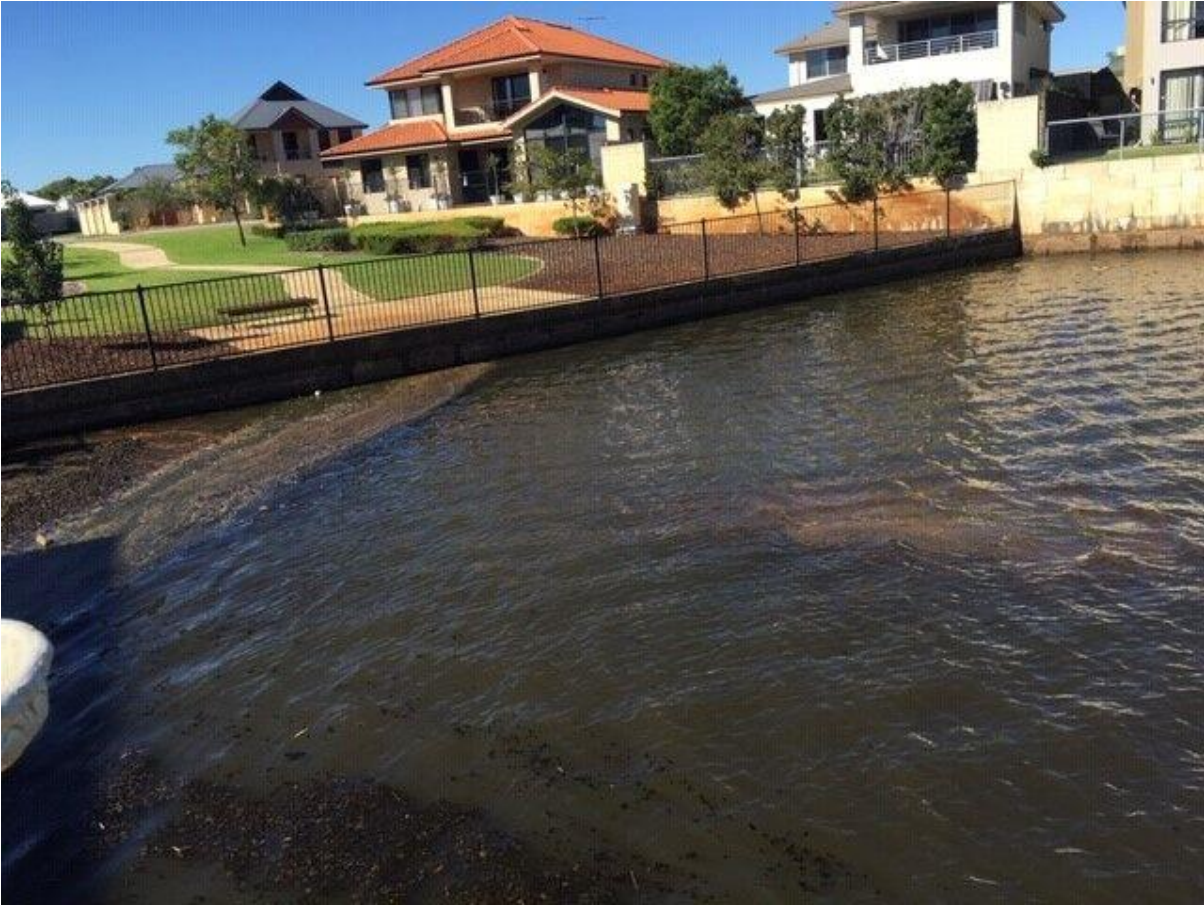
Sediment accumulation at the Inflow northern end: lake level at 10.25 m (March 28 2019)

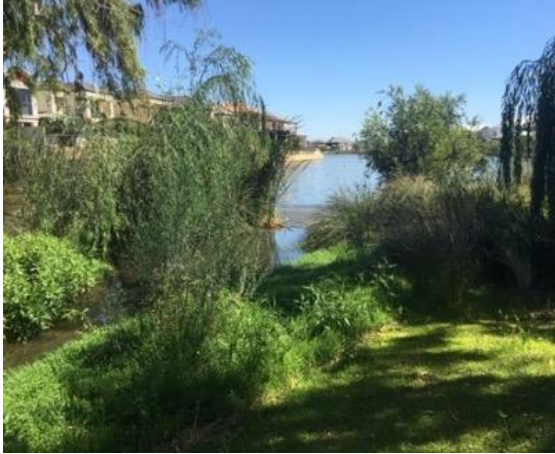
Lake outlet stream at the southern end

Before clean up (February 20 2019)

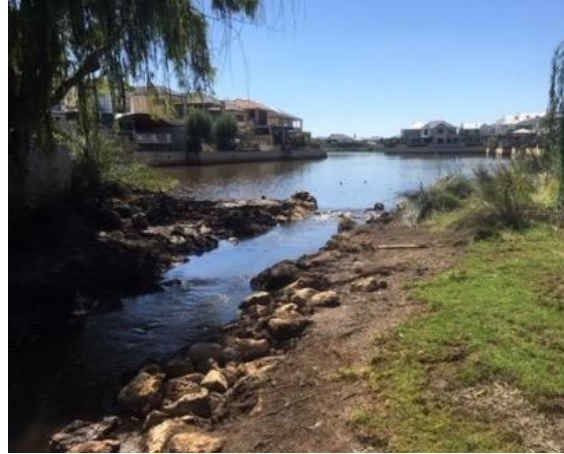
After clean up (March 28 2019)
