Eric Singleton Bird Sanctuary Constructed Wetland: Monitoring and assessment for optimal stormwater treatment performance

Regional Project 6-4

Carlos Ocampo and Carolyn Oldham (The University of Western Australia)

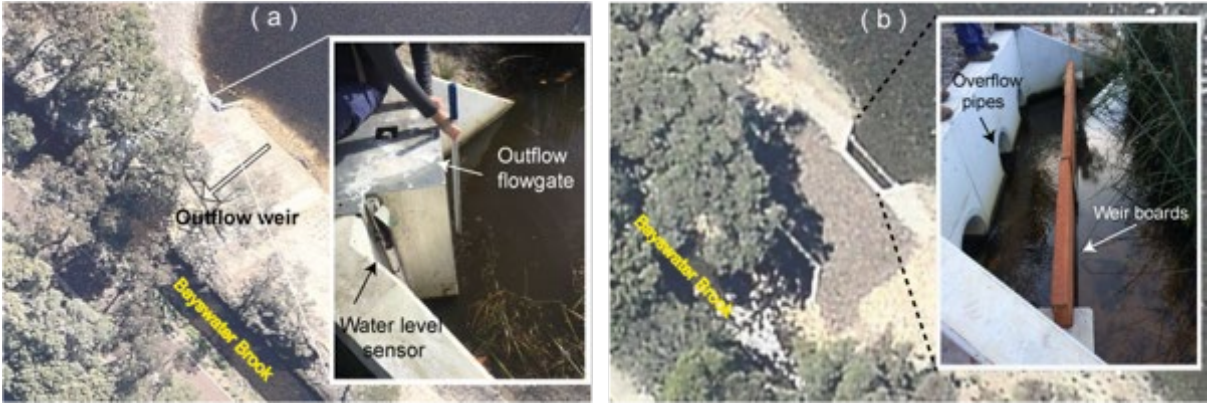
Figure 4 Outflow structures controlling discharge from ESBS; a) main Outflow point and associated surface overflow weir, b) Overflow structure and wooden boards weir used in management actions to control water levels in the wetland.

<p>Surface area for operational levels of 29,700 m², and extended detention volume of 14,822 m³.</p> <p>Vegetated area (shallow pools); Open water areas (depth 1 m) followed by submerged marsh, deep marsh zones (depth 0.45–1 m) and shallow marsh (depth 0.15 m) in the wetland bend areas.</p>
<p>Outlet mechanism</p>	<p>An Outflow structure comprises submerged concrete pipe (0.4 m diameter) and a Penstock watergate. Movable floodgate designed to stop discharge and avoid tidal intrusion or stormflow from the Bayswater Brook. A large overflow weir (10 m wide, 6 m length, flow depth up 0.5 m) allows discharge to Bayswater Brook for high water levels (> 0.9 m AHD). See Figure 4a for details.</p> <p>An Overflow structure comprises a concrete culvert (3 m wide x 5 m length, 3 x 0.45 m pipes with movable floodgates) and removable weir boards (board dimensions 1 m length x 0.1 m high). See Figure 4b for details.</p>

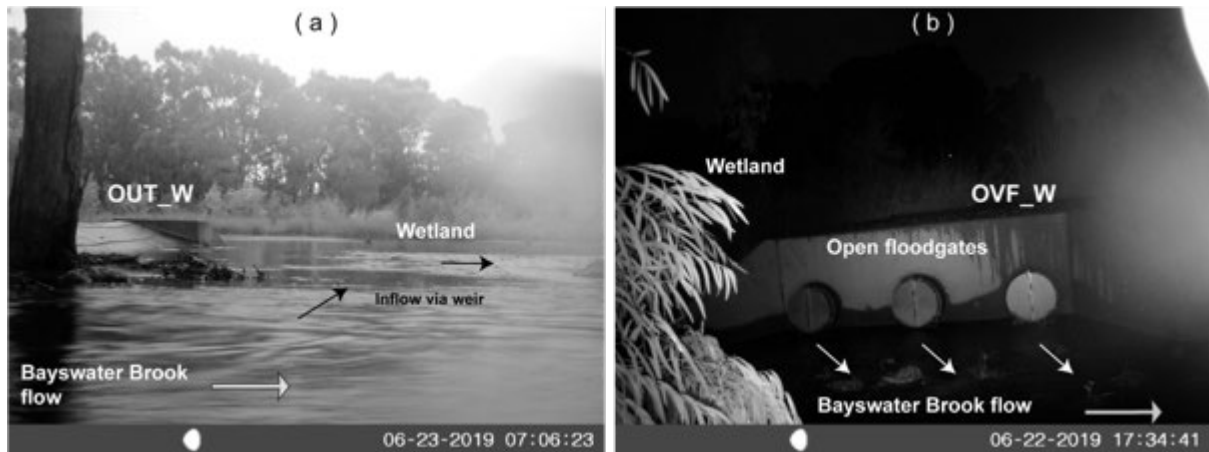
Figure 8 Camera stills used in flow monitoring at ESBS Outlet and Overflow: a) water exchange between Bayswater Brook and the wetland via weir structure, and b) discharge from wetland to Bayswater Brook at OVF_W under high water levels (note floodgates upward allowing discharge).

At OUT_W, the weir structure was also monitored, because water exchange between the wetland and the Bayswater Brook could occur under high water level. Surveying work provided the necessary weir dimensions and elevation thresholds for water overtopping (see Appendix 2), and a water level sensor (BB_OUT, see Figure 5 for location) and field camera recorded water level dynamics for discharge computations and flow direction (e.g. from Bayswater Brook to wetland or vice versa). Discharge was computed using the Area-Velocity method by means of Manning's equations. Figure 8 illustrates flow conditions captured by the cameras during high flow in the Bayswater Brook at the OUT_W and OVF_W.

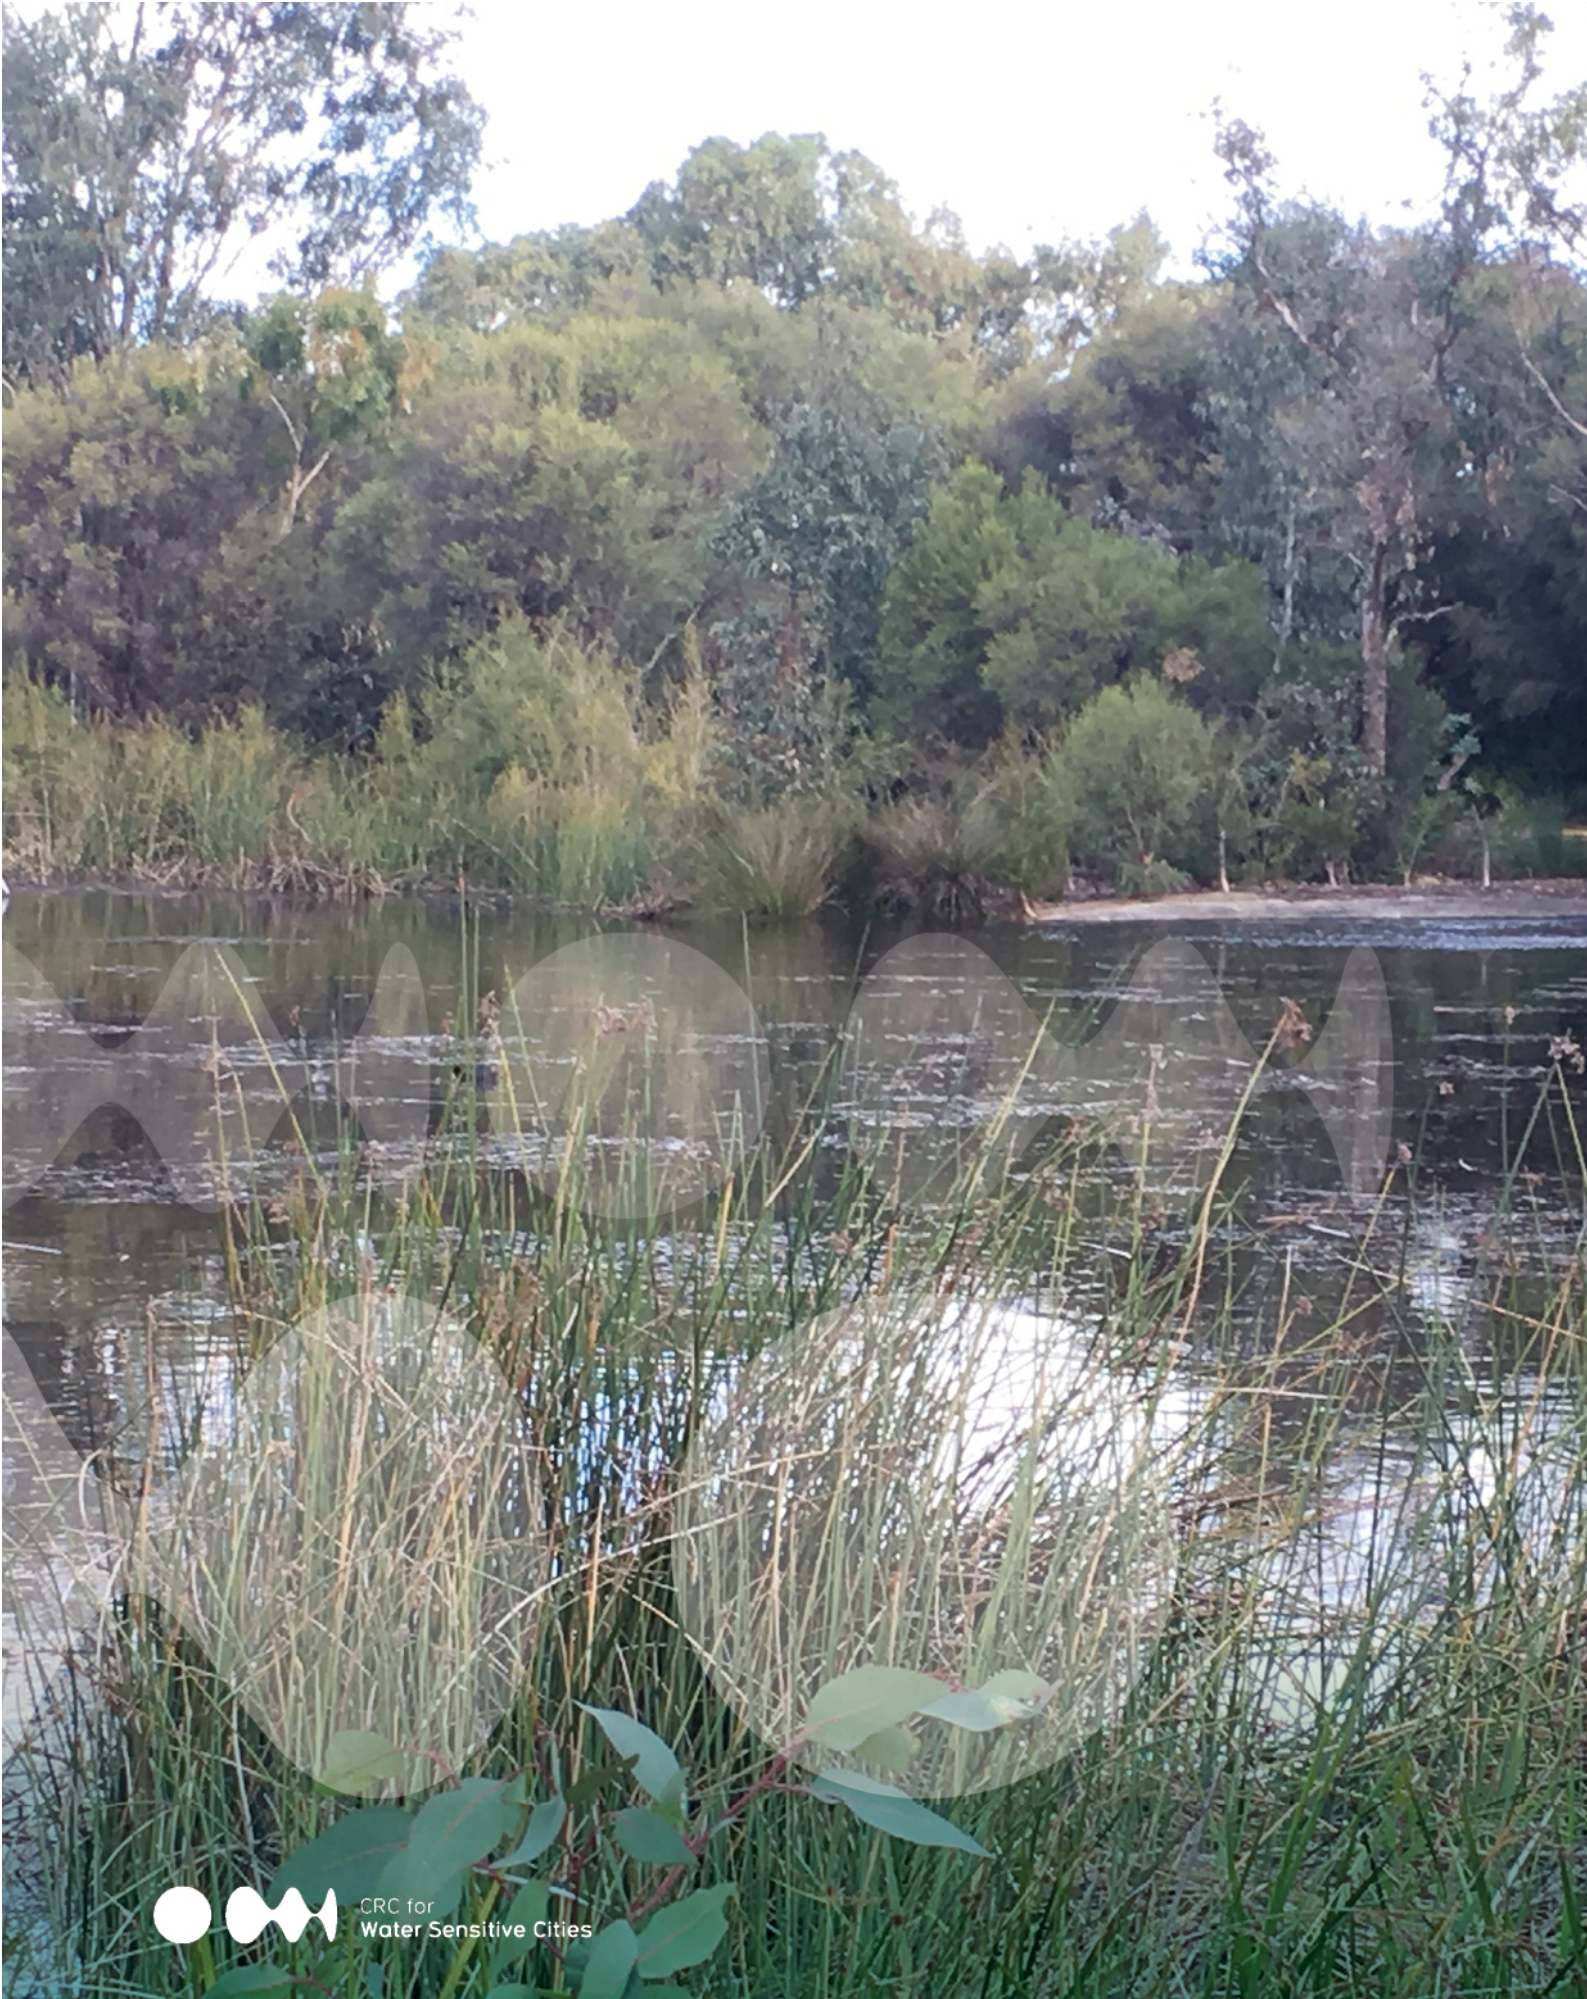
Figure 53 Stage two monitoring and sampling strategy for groundwater interaction and in-within wetland processes. Arrows indicate flow direction. Image source: Nearmap.

Finally, monitoring activities recommended for stage two are listed below, and should focus on quantifying groundwater inflows from point and non-point sources (e.g. Slade Street drainage pipe) and in-within wetland processes. The locations around the wetland component expected to account for most of the nutrient and sediment attenuations are shown in Figure 53:

- Flow monitoring (rating) of Slade Street drainage pipe inflow
- Monitoring of groundwater (e.g. water levels, water quality and nutrients)
- Sediment and macrophyte sampling be extended to other locations such as the sedimentation pond and the wetland area between OUT_W and OVF_W sites
- Move water sample point from OVF_W site to a new upstream location apart by 100 m (e.g. outlet of the proposed macrophyte sampling area in Figure 53).
