Eric Singleton Bird Sanctuary Constructed Wetland: Monitoring and assessment for optimal stormwater treatment performance

Regional Project 6-4

Carlos Ocampo and Carolyn Oldham (The University of Western Australia)

Date of publication: May 2020

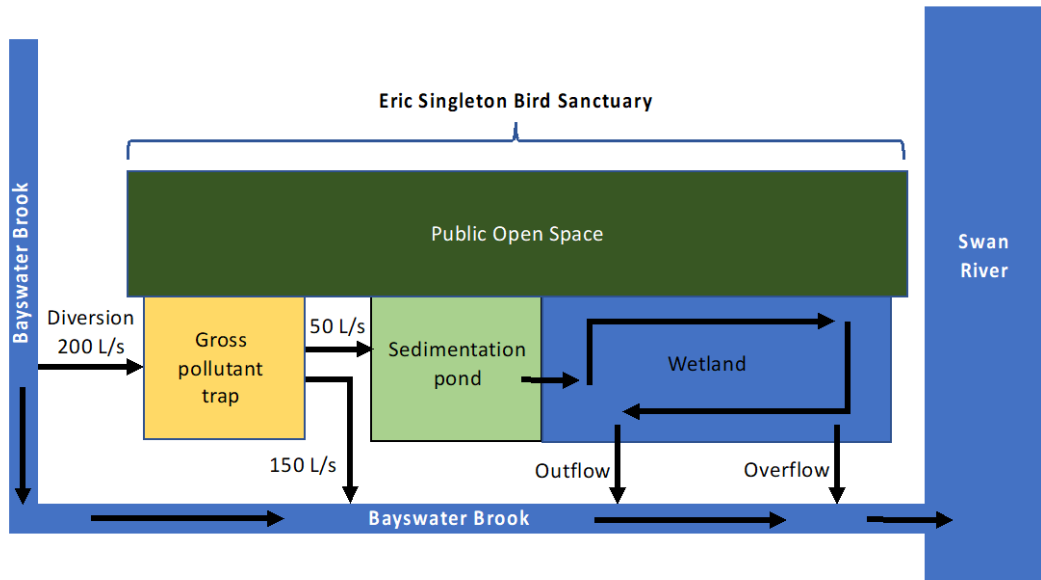
Figure 2 The ESBS wetland treatment components.

The wetland components and associated inflow and outflow structures are presented in Figure 2. Water is diverted directly from the Bayswater Brook via a weir structure and a 0.5 m diameter concrete pipe.

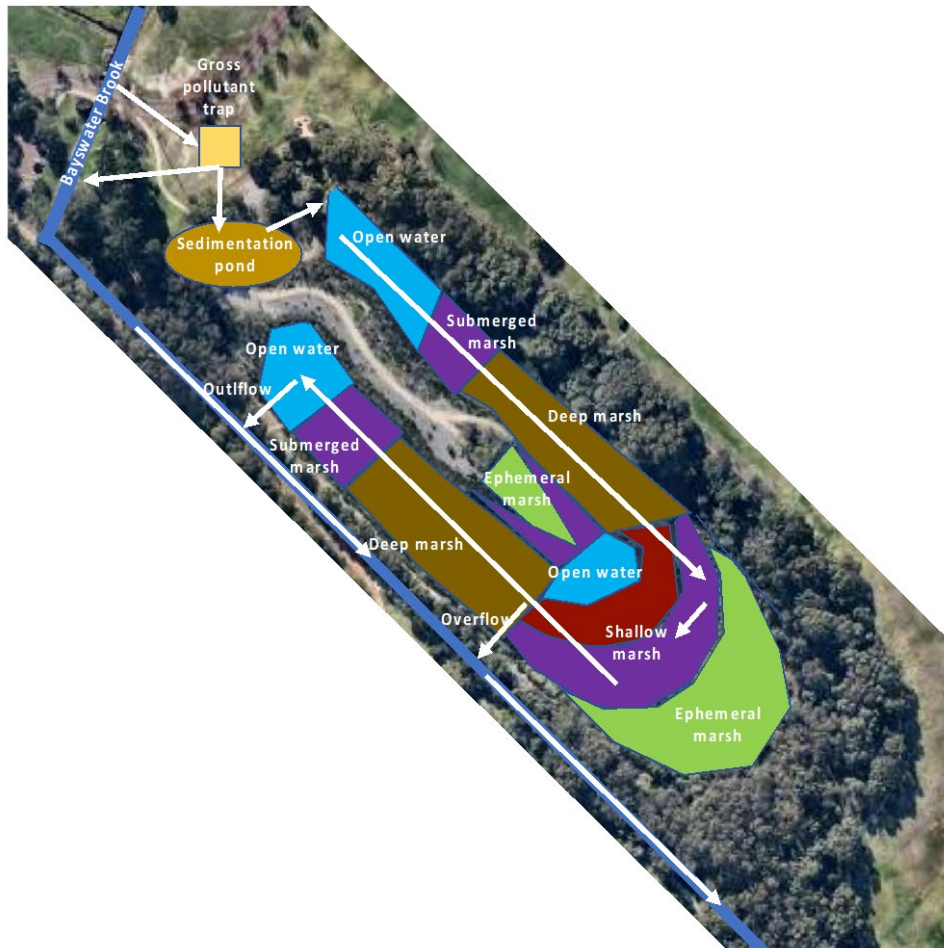
Figure 3 Design components, showing gross pollutant trap, sedimentation pond, open water and different marsh zones, and outflow and overflow to Bayswater Brook (modified from GHD 2013).

<p>Surface area for operational levels of 29,700 m², and extended detention volume of 14,822 m³.</p> <p>Vegetated area (shallow pools); Open water areas (depth 1 m) followed by submerged marsh, deep marsh zones (depth 0.45–1 m) and shallow marsh (depth 0.15 m) in the wetland bend areas.</p>
<p>Outlet mechanism</p>	<p>An Outflow structure comprises submerged concrete pipe (0.4 m diameter) and a Penstock watergate. Movable floodgate designed to stop discharge and avoid tidal intrusion or stormflow from the Bayswater Brook. A large overflow weir (10 m wide, 6 m length, flow depth up 0.5 m) allows discharge to Bayswater Brook for high water levels (> 0.9 m AHD). See Figure 4a for details.</p> <p>An Overflow structure comprises a concrete culvert (3 m wide x 5 m length, 3 x 0.45 m pipes with movable floodgates) and removable weir boards (board dimensions 1 m length x 0.1 m high). See Figure 4b for details.</p>

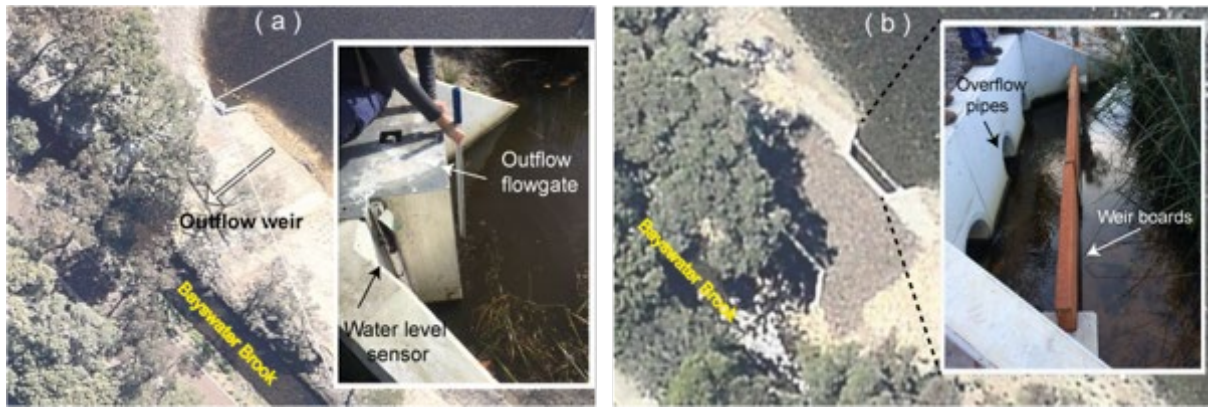
Figure 4 Outflow structures controlling discharge from ESBS; a) main Outflow point and associated surface overflow weir, b) Overflow structure and wooden boards weir used in management actions to control water levels in the wetland.

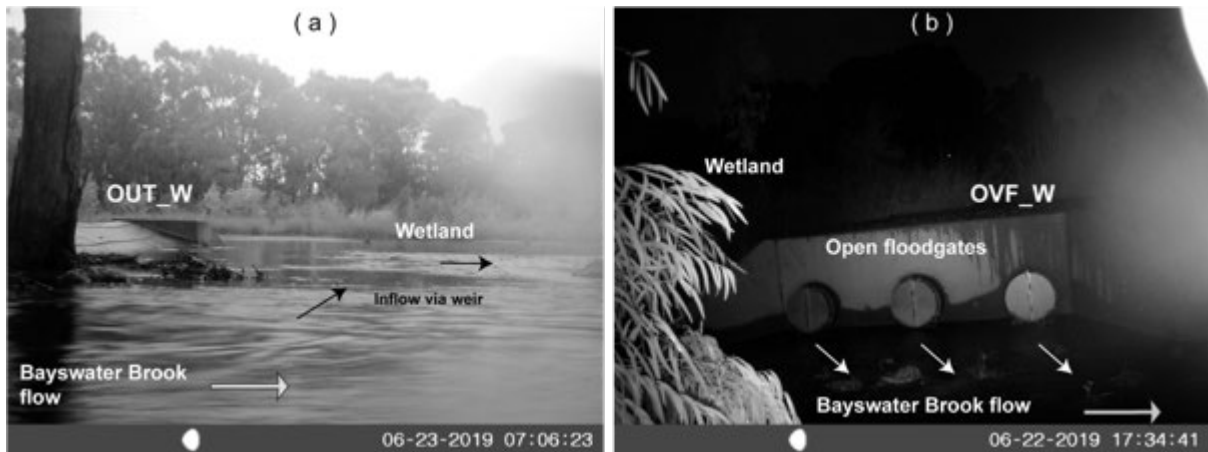
Figure 8 Camera stills used in flow monitoring at ESBS Outlet and Overflow: a) water exchange between Bayswater Brook and the wetland via weir structure, and b) discharge from wetland to Bayswater Brook at OVF_W under high water levels (note floodgates upward allowing discharge).

At OUT_W, the weir structure was also monitored, because water exchange between the wetland and the Bayswater Brook could occur under high water level. Surveying work provided the necessary weir dimensions and elevation thresholds for water overtopping (see Appendix 2), and a water level sensor (BB_OUT, see Figure 5 for location) and field camera recorded water level dynamics for discharge computations and flow direction (e.g. from Bayswater Brook to wetland or vice versa). Discharge was computed using the Area-Velocity method by means of Manning's equations. Figure 8 illustrates flow conditions captured by the cameras during high flow in the Bayswater Brook at the OUT_W and OVF_W.

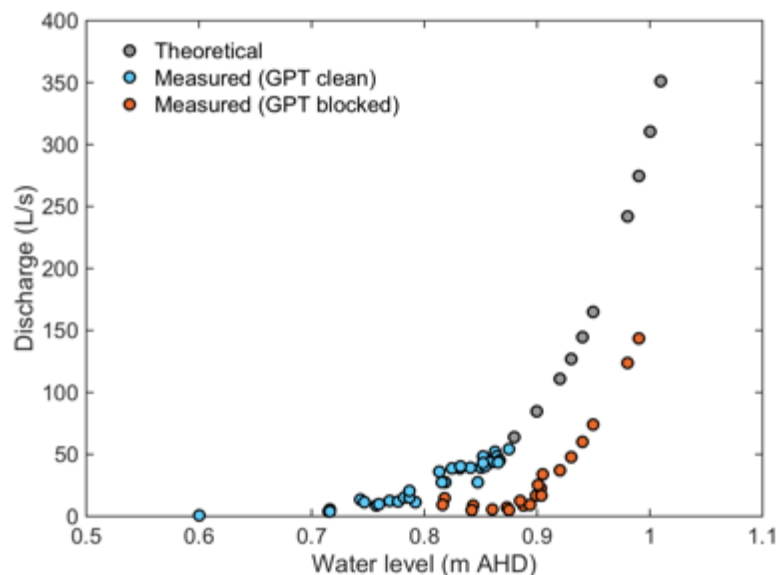
Figure 11 Rating curves for PIT1_IN. Orange dots correspond to the period when the GPT was blocked.

The GPT cleaning operation took place in early September 2019 and afterwards high flow and water levels were recorded in both PIT1_IN and SED_P (0.95 m AHD) for a measured discharge of 156 L/s into the sedimentation pond. This result confirmed that such flow magnitudes could be expected during storm events, as predicted by the theoretical rating.

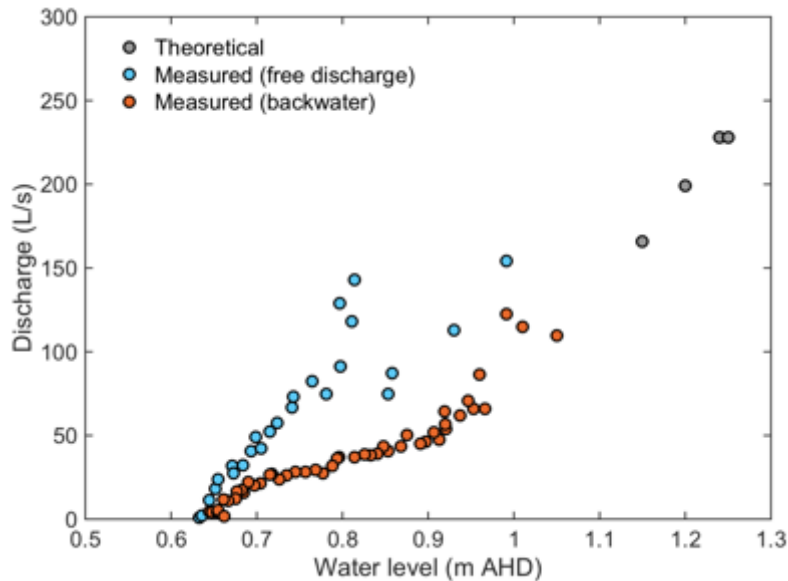
Figure 12 Rating curves for the OVF_W. Curves correspond to levels in the single central pipe of the culvert structure. Blue dots indicate low water conditions, and orange dots indicate high water conditions, in Bayswater Brook.

Figure 12 shows two rating curves related to the water levels measured in the central pipe of the Overflow structure (m AHD) or at the staff gauge plate adjacent to the culvert. The blue dots represent outflow discharge from the pipe, when there is neither tidal influence nor high water levels in Bayswater Brook. The rating extends to 0.95 m AHD, before the water reaches the top of the pipe at the upstream end. Theoretical flow discharge estimates were used to extrapolate the curve for water levels greater than 1.1 m AHD. Estimates for theoretical discharge values used observed water levels at upstream, inside the pipe and downstream points. The orange dots provide discharge values influenced by high water levels in Bayswater Brook (either tidal, stormflow or a combination of both). These results demonstrate a large difference in wetland discharge when water levels are less than 0.9 m AHD, depending on flow conditions in Bayswater Brook.

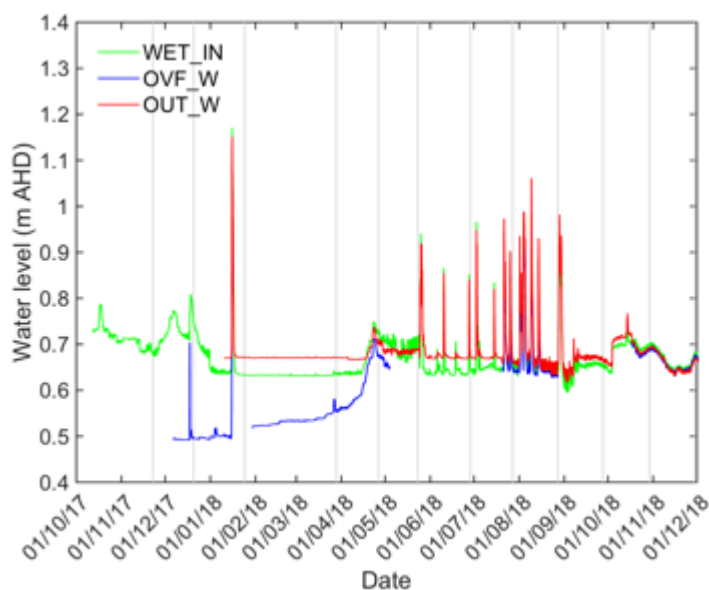
Figure 14 Water level time series from October 2017 to December 2018. Data is shown from Wetland inlet (WET_IN), Overflow (OVF_W) and Outflow (OUT_W). Data gaps represent sensor malfunctioning and loss of OVF_W sensor (from late August to early November 2018).

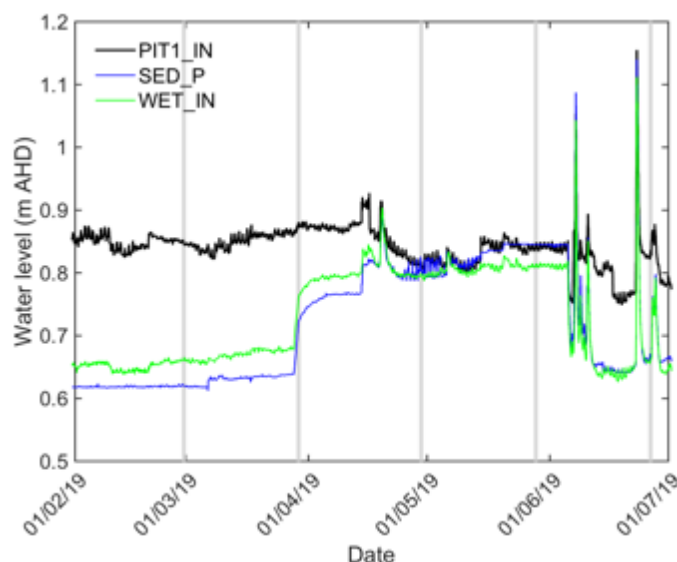
Figure 16 Water levels at selected monitoring stations from February to June 2019. Variation in levels was observed as flows responded to wetland management operations. Wetland levels increased to 0.80 m AHD due to the addition of two boards at the Overflow structure (OVF_W site), and later their removal in preparation for winter season inflows.

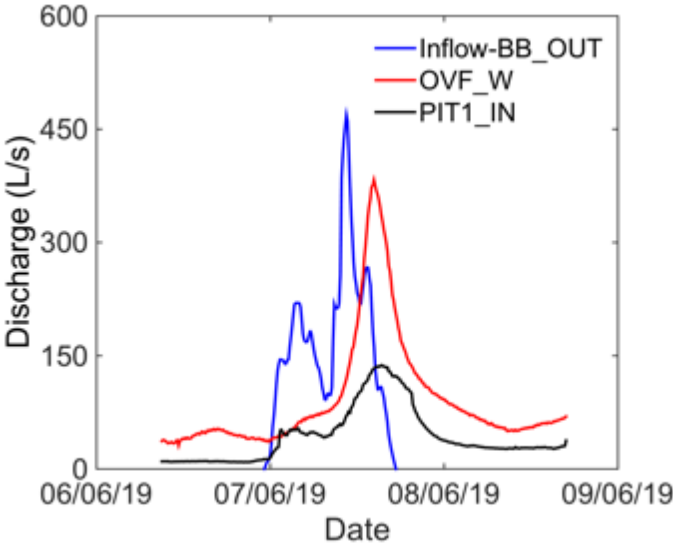
Figure 17 Event 1 flow hydrographs. The Inflow-BB_OUT hydrograph indicates inflow from Bayswater Brook to the wetland via the large weir at the Outlet structure.

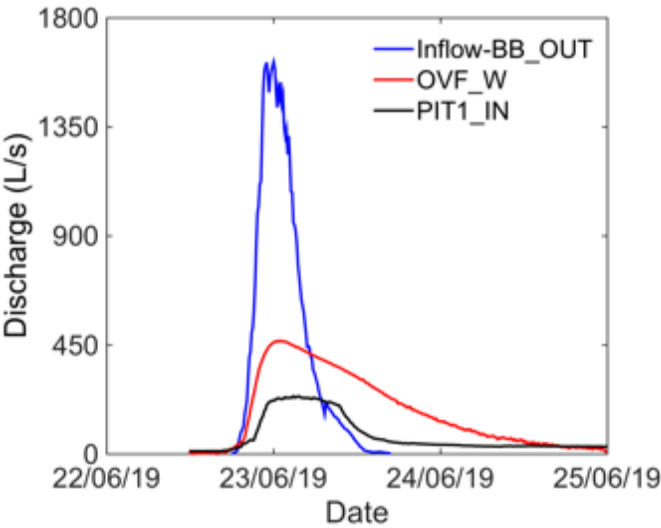
Figure 18 Event 2 flow hydrographs. The OVF_W hydrograph shows good discharge conditions over the course of the event.

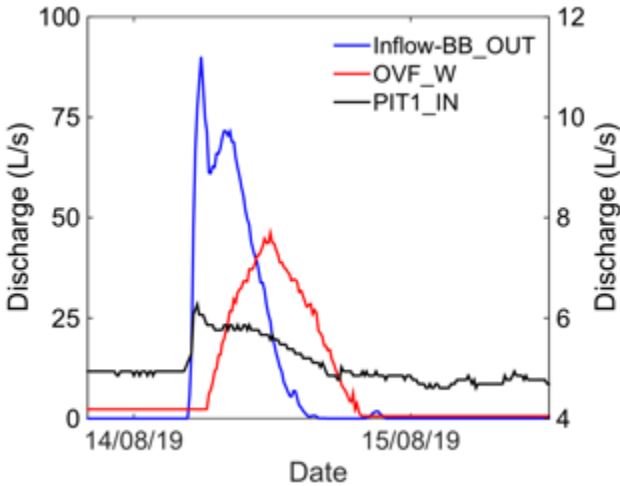
Figure 20 Event 4 flow hydrographs. Refer to right y-axis for PIT1_IN hydrograph discharge values.

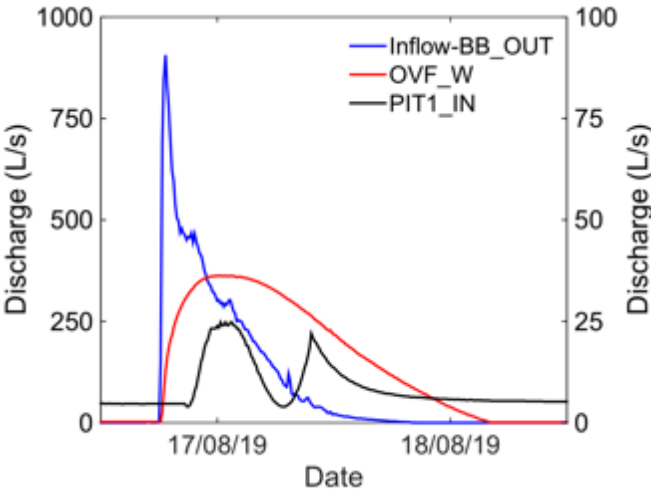
Figure 21 Event 5 flow hydrographs. Refer to the right y-axis for PIT1_IN hydrograph discharge values.

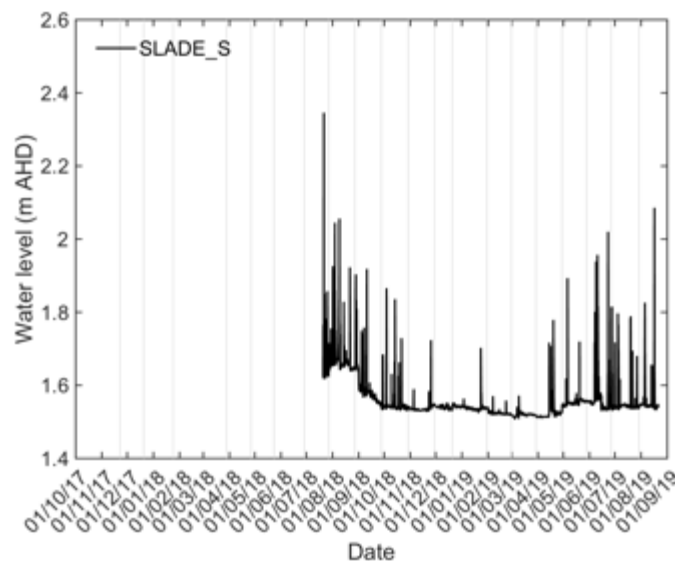
Figure 22 Water level for SLADE_S. Data were recorded between 20 June 2018 and 21 August 2019.

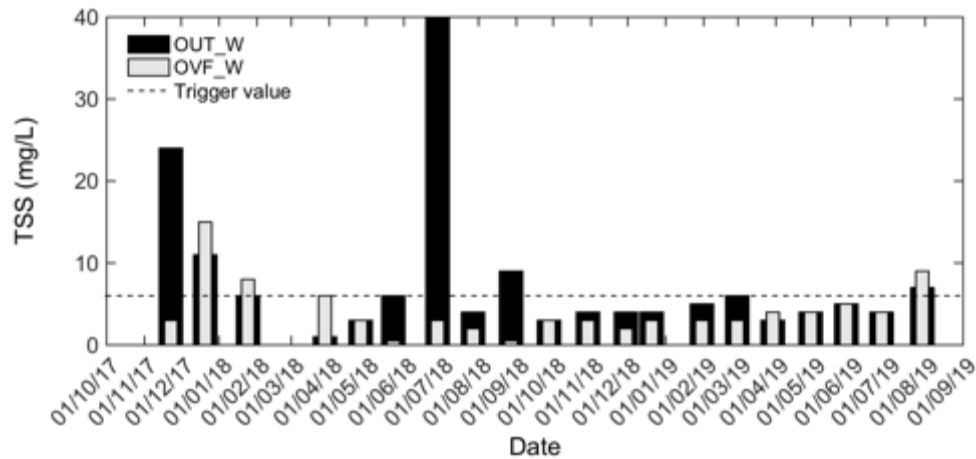
Figure 32 Comparison of TSS concentrations at OUT_W and OVF_W. Trigger value corresponds to interim guideline concentration of 6 mg/L (Department of Water and Environmental Regulation).
